THEORETICAL AND EXPERIMENTAL EVALUATION OF TIMBER-FRAMED PARTITIONS UNDER LATERAL DRIFT

Jitendra Bhatta¹, Joshua Mulligan², Rajesh P. Dhakal³, Timothy J. Sullivan⁴, Hans Gerlich⁵ and Frank Kang⁵

ABSTRACT

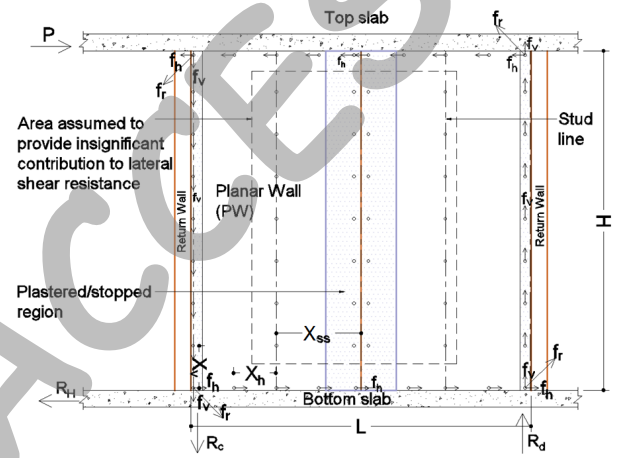
Figure 1: Schematic diagram of force transfer through a rigid partition wall

The shear strength of an internal partition wall is commonly predicted based on the shear strengths of the screw between the sheathing and internal framing [44, 45]. The type of frame and the spacing of framing members are not expected to significantly contribute to the bracing strength of the wall [46]. It is generally observed that the screw failures occur around the wall perimeter and at the top and bottom runners (or plates) [47–50]. It has been assumed that the lateral force acting on the top runner of the wall is transferred to the sheathing through the top screws and to the bottom runner by the screws at the bottom boundary, as shown in Figure 1.

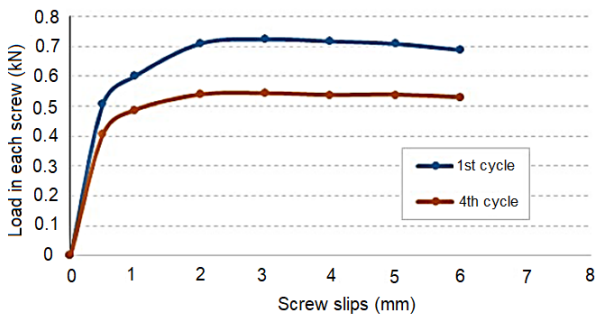
Figure 2: Example of a screw-slip curve from several tests on timber-frame [54]

From past experimental results, it is found that the shear strength f_r of gypsum plasterboard-to-timber screws (with screw gauge numbers 6, 8 and 10) is 0.5 kN [44, 47, 52–54] and 0.66 kN [53] for single and double-layers of 10–12mm boards, respectively. However, overdriven screws and saturated/soaked plasterboard can reduce the shear strength f_r of the connections by a factor of 1.3 and 4, respectively [55]. There are several published articles from which the values of f_r can be obtained [47, 52–54]. One of the examples of the screw-slip curve is shown in Figure 2. In this figure, the maximum load in the screw is its shear strength, and

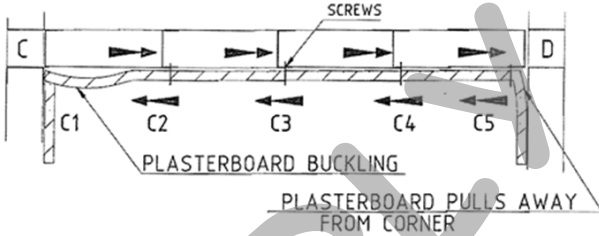
Figure 3: Sectional plan view showing the failures of plasterboard [44]

Local buckling of horizontally oriented gypsum plasterboards was observed by Golledge et al. [44] in a partition wall with return ends, as shown in Figure 3. The plasterboard section buckled when the acting axial load exceeded the buckling load of the plasterboard. In their study, the buckling load was calculated as:

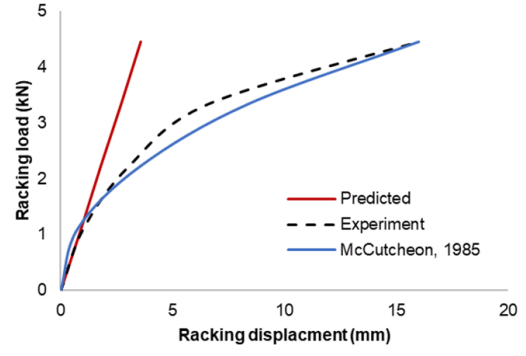
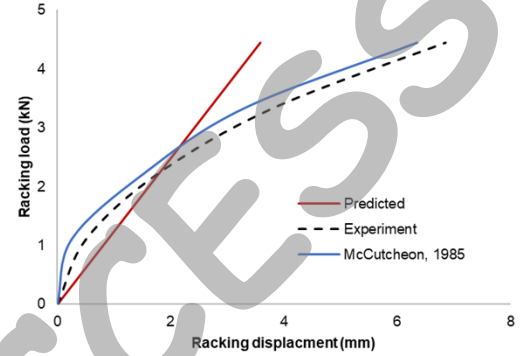
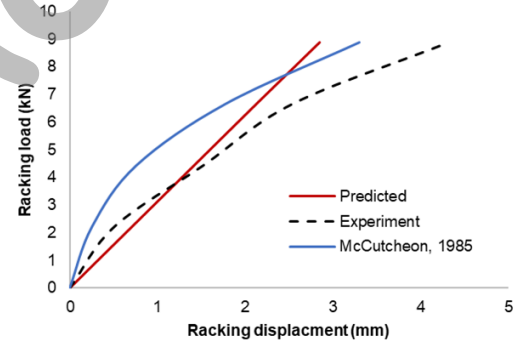
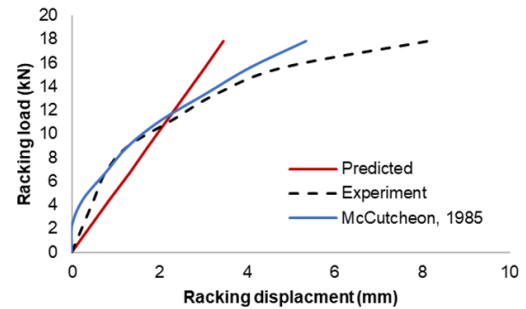
(a) 8ft (2440 mm) by 8 (2400 mm) wall with 8 in (203mm) screw spacing, two 4ft (1220 mm) long sheets

(b) 8ft (2440 mm) by 8 (2400 mm) wall with 8 in (203mm) screw spacing, one 8ft (2440 mm) long sheet

(c) 8ft (2440 mm) by 16 ft (4880 mm) wall with 8 in (203 mm) screw spacing, one 16ft (4880 mm) long sheet

(d) 8ft (2440 mm) by 24 ft (7315 mm) wall with 8 in (203 mm) screw spacing, one 24ft (7315 mm) long sheet

Figure 4: Load-displacement curves for walls [68]

In Figure 4, it can be observed that the line connecting the origin with the ultimate displacement given by equation 16 can reasonably estimate the equivalent elastic stiffness (specially in Figure 4a), whereas it consistently underestimates the racking displacements at higher load levels in all cases. Hence, this equation cannot be relied to predict the lateral in-plane response of partition walls.

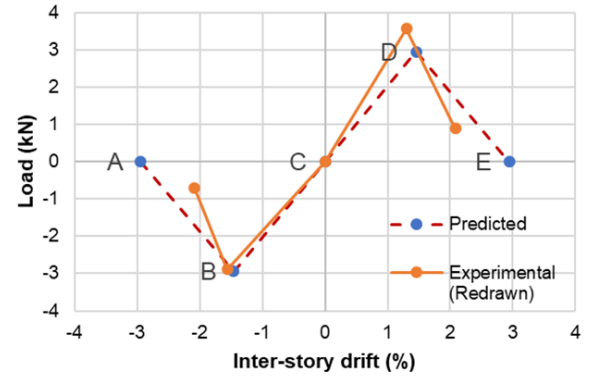
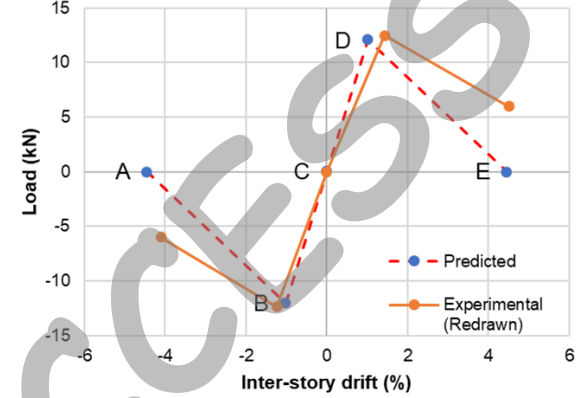
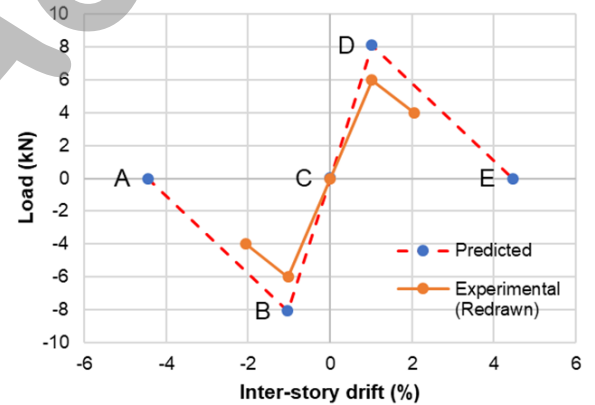
(a) Specimen NDS from Amer et al., 2016 [50]

(b) Specimen WSC1 from Memari et al., 2009 [63]

(c) Specimen MSC1 from Memari et al., 2009 [63]

Figure 5: Comparison between predicted and experimental backbone curves (redrawn as bilinear curves)

Assuming symmetrical behaviour of a partition wall under lateral loads interconnecting the points: $A(-\theta_{bk}, 0)$, $B(-\theta_{ult}, -P_{ult})$, $C(0, 0)$, $D(\theta_{ult}, P_{ult})$ and $E(\theta_{bk}, 0)$ form a bilinear backbone curve (see Figure 5). Here, θ_{bk} is assumed to be the drift, which represents the very extreme damage state of partition walls at which the wall's capacity theoretically reaches zero. The line BA and DE are represented as lines with a negative slope indicating progressive damage occurring to the partition wall at increasing drift levels; instead of a straight line suddenly dropping to zero at A and E when θ_{bk} is reached. The predicted and experimental backbone curves (redrawn as bilinear curves) of several partition walls found in the literature [50, 63] are shown in Figure 5. It can be observed that the predicted curves can reasonably approximate the experimental bilinear backbone curves.

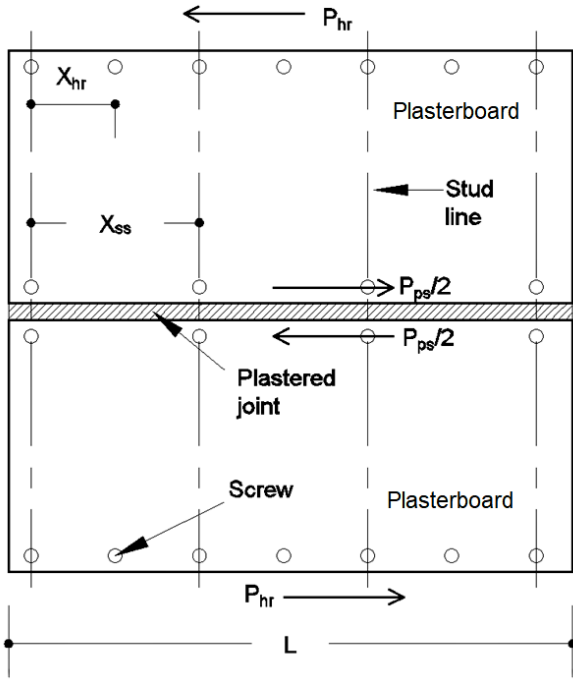
Figure 6: Schematic diagram of force transfer mechanism through plastered joint in horizontally oriented plasterboards

In horizontally oriented plasterboards, shear strength of the plastered joint between the plasterboards can be taken as equal to that of the shear strengths of the screws present along both sides of the joint of the wall, as shown in Figure 6. For one of the plasterboards,

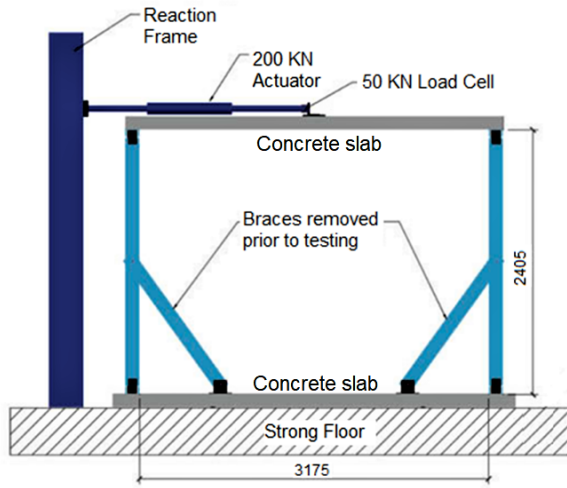
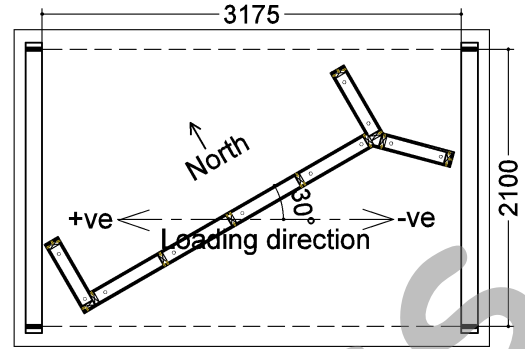
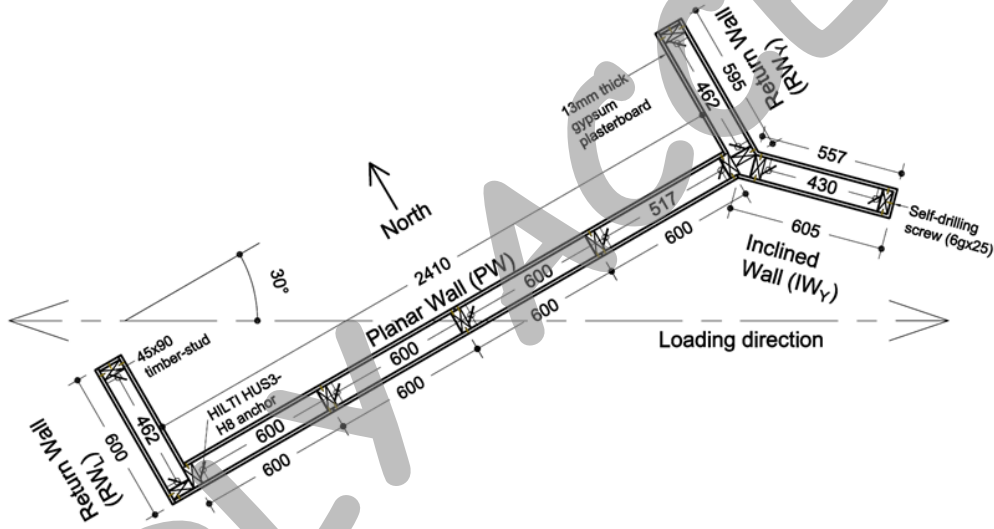
(a) Steel-frame structure-elevation [30]

(b) Steel-frame structure with 'y' shaped TFW specimen-plan [30]

(c) Details of TFW specimen-plan

Figure 7: Test setup and specimen details

A rigid timber-framed wall (TFW) specimen with details commonly used to construct interior partition walls in NZ buildings was constructed between two parallel concrete slabs supported by steel frames, as shown in Figure 7a.

Following the typical practice in NZ, horizontal timber runners (90 mm x 45 mm) were fastened to the concrete slabs (i.e., ceiling slab and floor slab) using anchor bolts (HILTI® HUS3-H8) at spacings shown in Figure 7c during the construction of the specimen. Then, timber studs (90 mm x 45 mm) were attached at a regular spacing of 600mm c/c to these runners by driving 3 nails at an angle (2 from one side and 1 from the other). The vertical joint at the south of the Y-junction was reinforced with 135° 0.55BMT (Base Metal Thickness) galvanized steel angles screwed to the studs. A single layer of 13 mm thick gypsum plasterboard was attached to the studs as well as runners using GIB® grabber self-tapping drill point screws (6g x 25 mm) on both sides of the walls. The spacing between the screws was kept at 300 mm c/c along the boundaries and in the field of the

The test frame, shown in Figure 7a, was hinged at the beam-column connections and at the bases of the columns to allow a shear mode of deformation under applied lateral cyclic displacements at the top of the frame. The top and bottom of the frame were connected to 120 mm thick reinforced concrete slabs with a clear height of 2405 mm between them. Further details on the

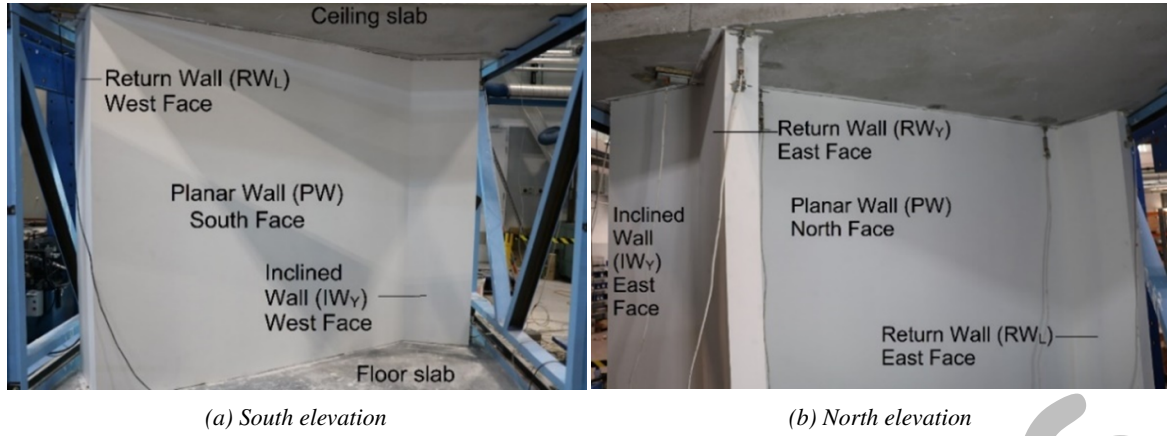
Figure 8: Photos of the specimen prior to testing

partition wall. Then, the joints were plastered with two coats of GIB® Tradeset 90-minutes premium jointing compound, jointing tape and internal and external corner beads (*/L-trims*), where necessary. A final coat of plaster was applied with GIB® Trade Finish. Finally, after sanding the surface, two coats of paint were applied on the wall surface before testing. The finished TFW specimen is shown in Figure 8.

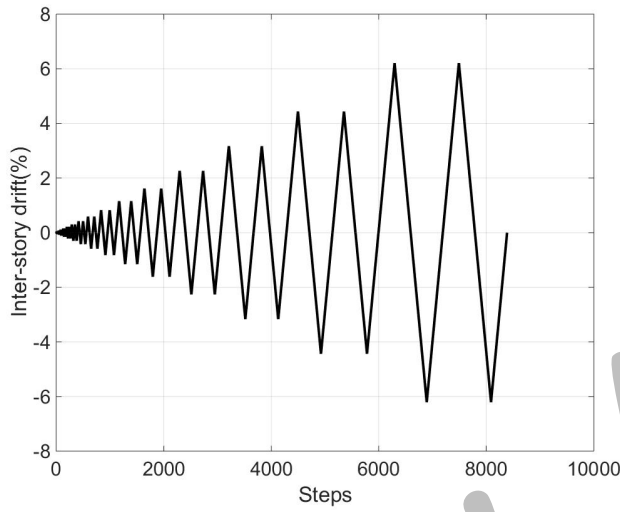
Figure 9: FEMA-461 loading protocol [70]

test frame can be found in [30, 31]. A 200 kN actuator supported by a reaction frame was attached to the centre of the ceiling slab using bolt connections. The load applied to the specimen was recorded with a 50 kN load cell with an accuracy of ± 3 N. The specimen was subjected to a displacement-controlled unidirectional quasi-static cyclic protocol defined in FEMA 461 [70], as shown in Figure 9.

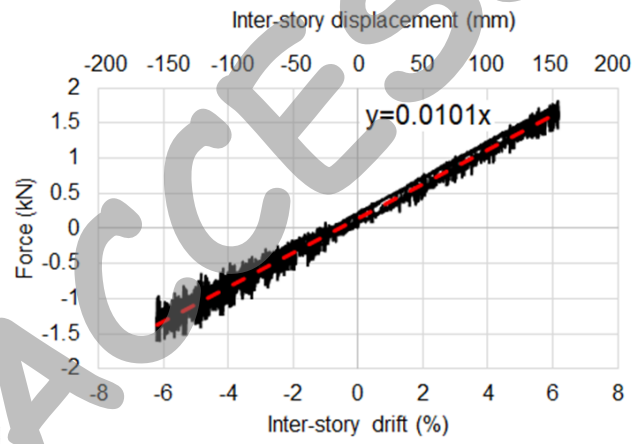
Figure 10: Force-displacement response of bare frame [30]

Two cycles were applied at each drift amplitude where the drift amplitude of each step was 1.4 times the amplitude of the preceding step. A total of 16 drift steps were applied, up to a maximum drift of 6.21% in the frame axis, which corresponds to a maximum in-plane and out-of-plane drifts of 5.38% (more than twice of the allowable ultimate limit state of 2.50% drift) and 3.10%, respectively, for the Planar Wall (PW). The response of the bare frame was approximately linear, with the stiffness of 10.1 N/mm, as shown in Figure 10. The specimen was in-

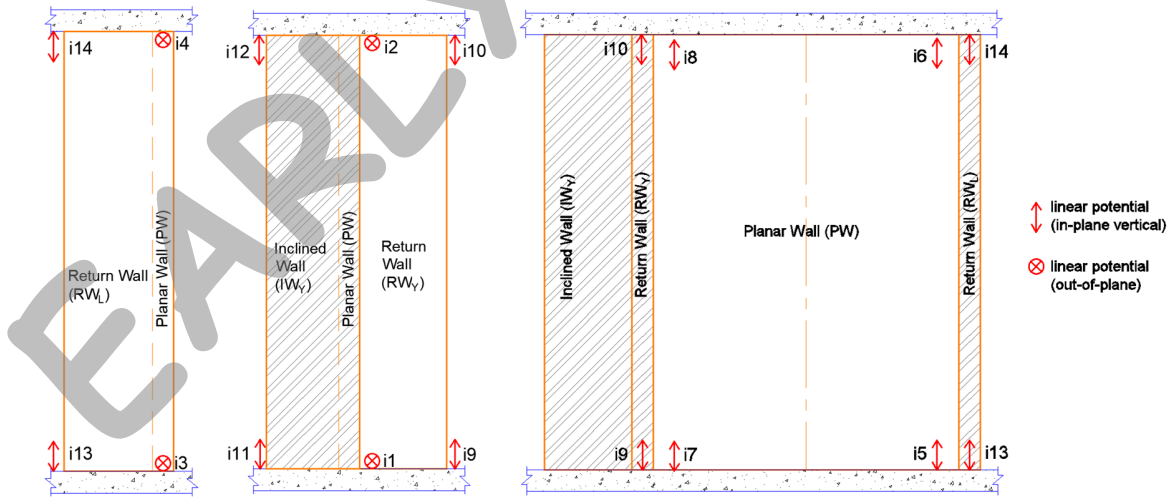
Figure 11: Instrumentation points: RW_L West Face (left), Y-junction East Face (center) and PW North Face (right)

strumented with linear potentiometers to measure the vertical and out-of-plane displacements, as shown in Figure 11. The potentiometers recorded the relative linear displacement between the locations they were secured on the TFW specimen and the surface of the concrete slab.

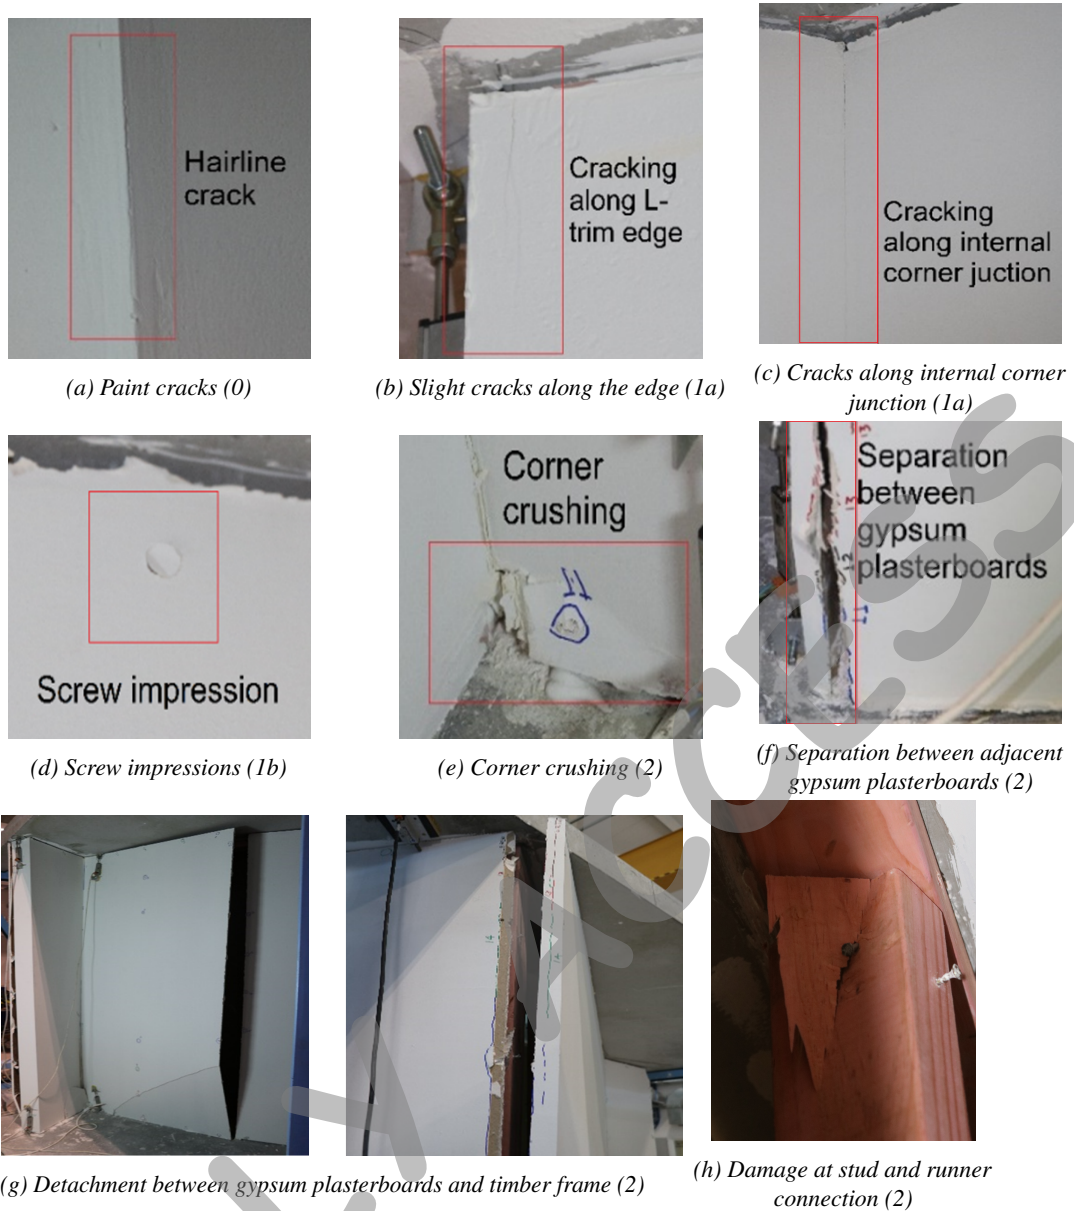
Figure 12: Examples of observed damage with damage states in brackets

is described in Table 6. Visual inspection of the specimen was done after each step of the applied FEMA 461 [70] loading protocol (Figure 9) and any damage observed was photographed and manually recorded. The observed damage during the experiment is shown in Figure 12.

Numerous cases of screw impressions were perceived in the finished compound over the screw-heads, particularly at the top and bottom boundaries of the plasterboard after step 9 (0.51% inter-story drift cycles corresponding to the Planar Wall) (Figures 12d and 13a). The screw impressions were found to propagate from the bottom boundary vertically towards the top boundary during

Gypsum plasterboard has relatively low compressive and tensile strengths which can result in early onset of damage [57, 71]. The corners of the gypsum plasterboards crushed, creating wrinkles on the outer paper during smaller drift cycles followed by distributed cracks at larger drift cycles (Figure 12e). The ripping of the joint tapes and widening of cracks along the corner beads (Figures 12f and 12g) were indicative of relative movements between adjacent gypsum plasterboards.

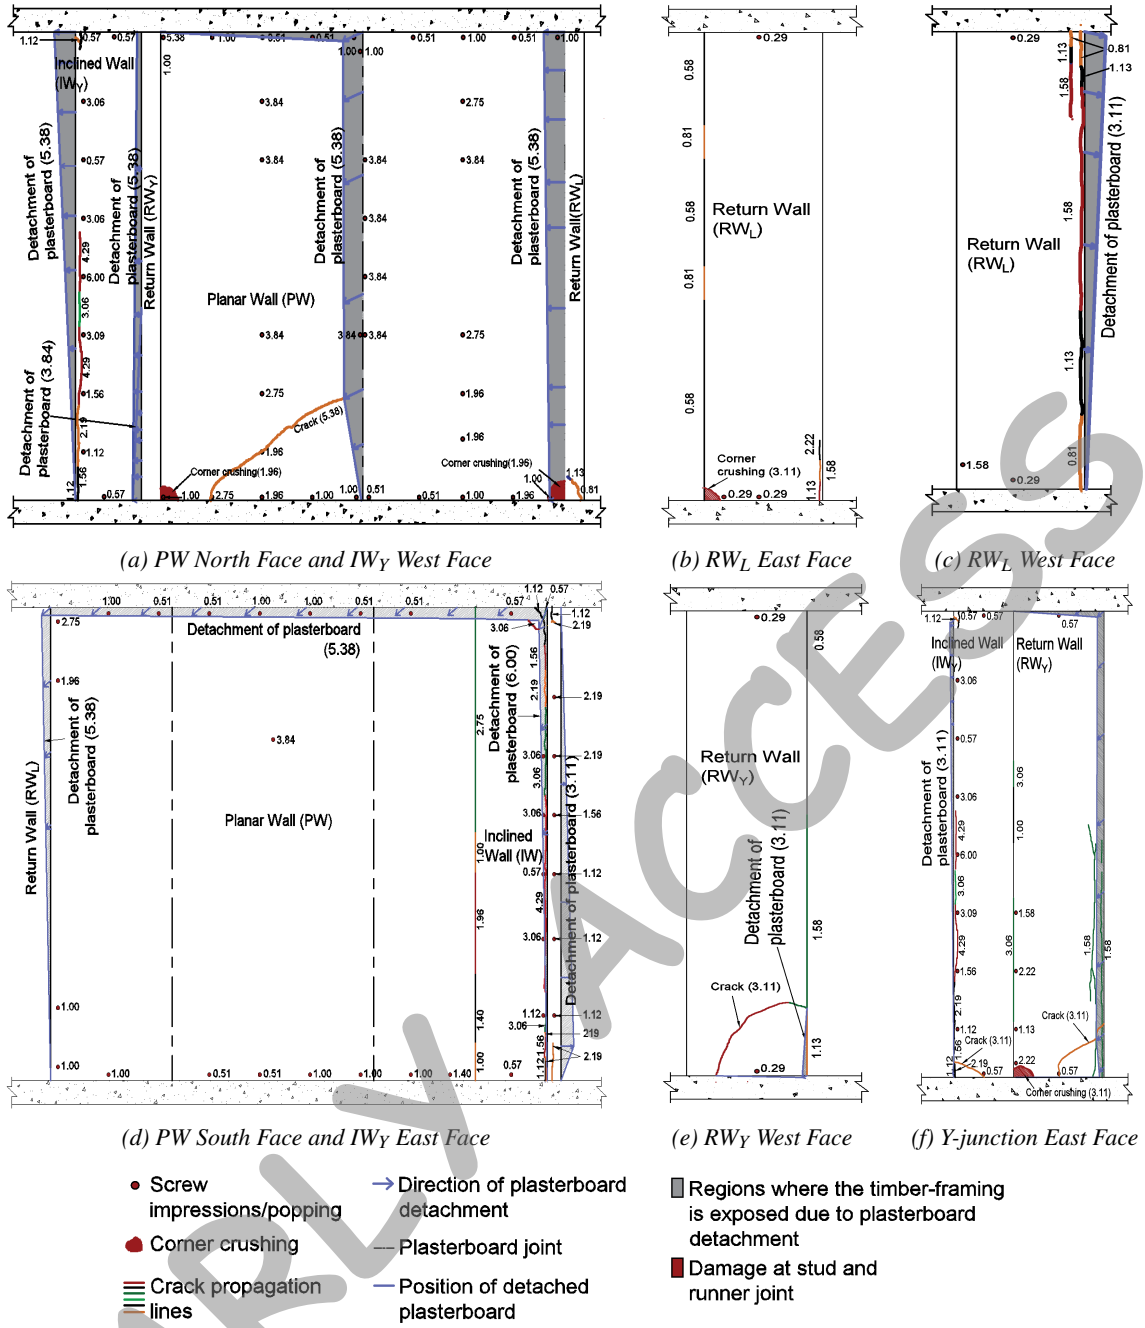
Figure 13: Schematic diagram of progression of damage with onset in-plane inter-story drifts for the walls

The inter-story drifts experienced by each wall type were different depending upon their orientation with the loading direction. The pictorial representation of the types of damage and their corresponding onset inter-story drifts associated with these wall types are shown in Figures 13 and 14.

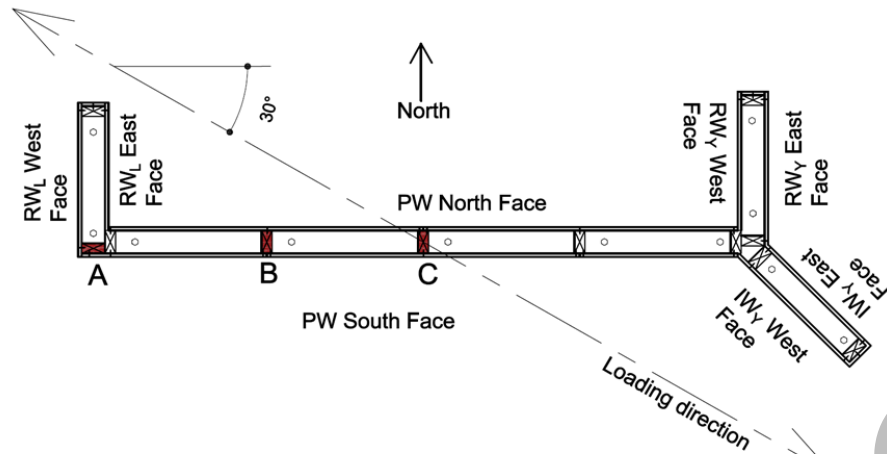
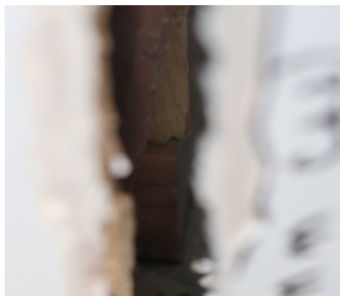
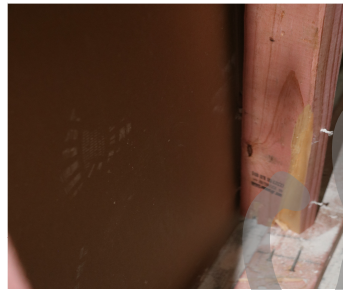
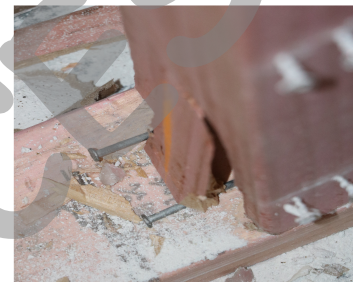
(a) Plan showing reference planes and locations of stud-to-runner connection damage (Legends as shown in Figure 13)

(b) Frame damage at A

(c) Frame damage at B

(d) Frame damage at C

Figure 14: Damage observed to timber stud-and-runner connections visible through detached gypsum plasterboards

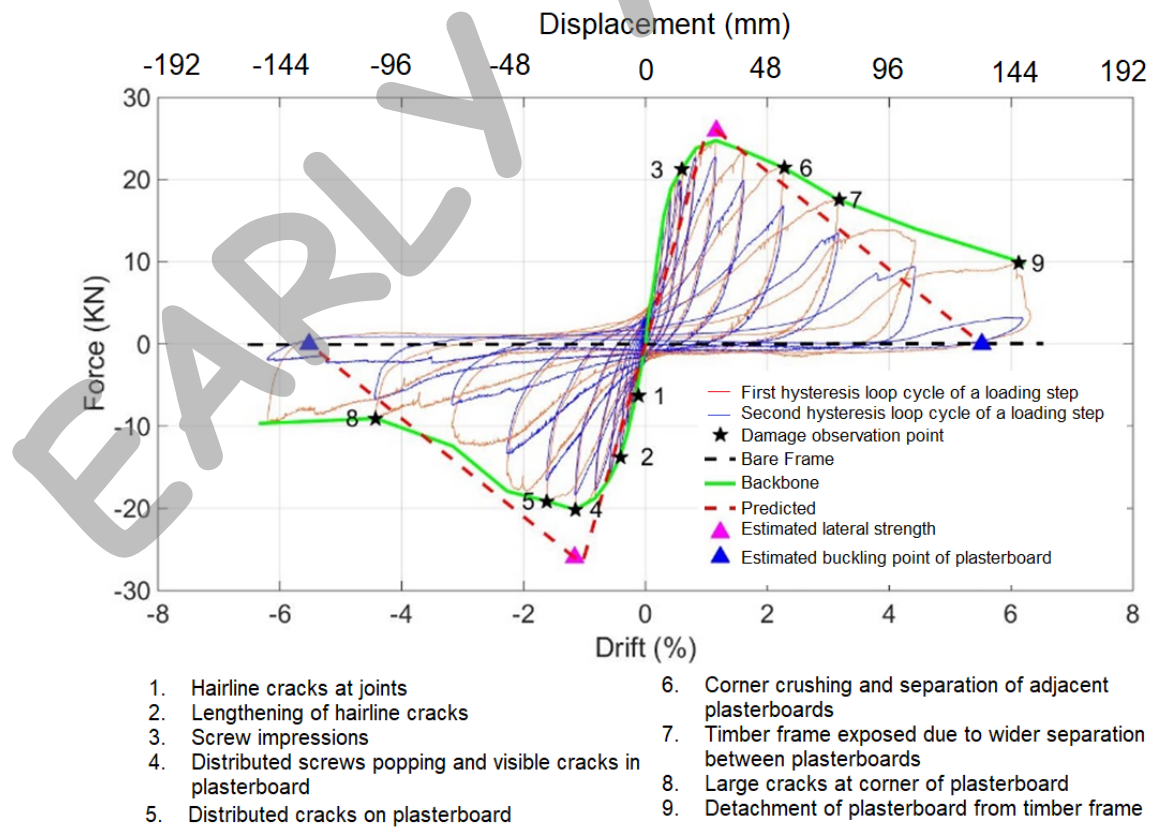
Figure 15: Hysteresis loop with damage points in the specimen

Since the original force-drift data obtained from the experiment was noisy, the moving average for each force value was taken (with window size 3, which incorporated one value before and after the considered value) to smoothen the curve. The resulting force-drift hysteretic loops are shown in Figure 15. Figure 15 also shows the loading stage corresponding to the onset of different damage observed during the test as the load-displacement envelope curve in the linear elastic region is predicted by interconnecting the points: $A(-\theta_{bk}, 0)$, $B(-\theta_{ult}, -P_{ult})$, $C(0, 0)$, $D(\theta_{ult}, P_{ult})$ and $E(\theta_{bk}, 0)$ for this specimen.

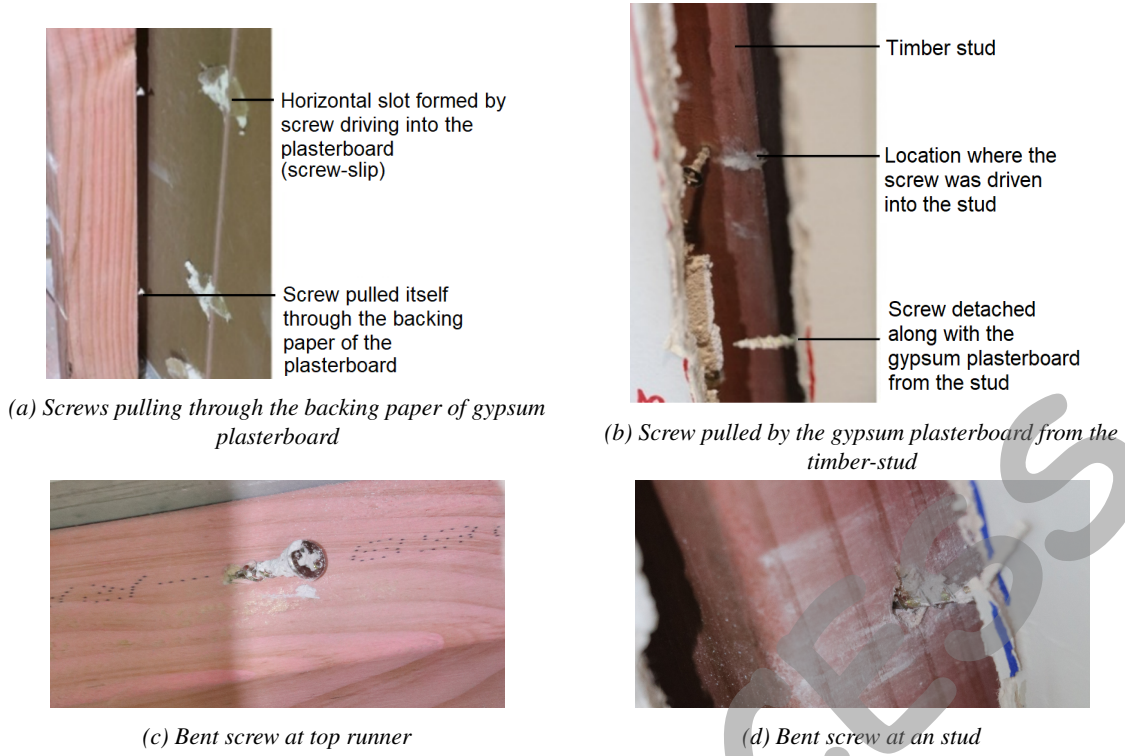
Figure 16: Bending and detachment of screws

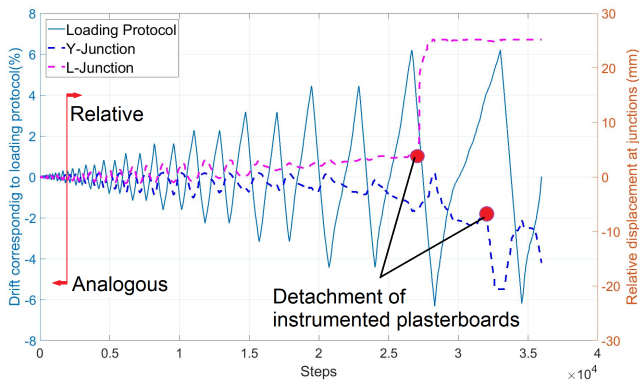
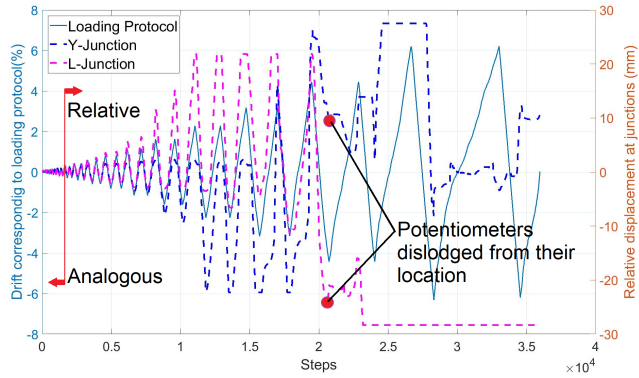
(a) At top of the junctions (at the ends of PW)

(b) At the bottom of the junctions (at the ends of PW)

Figure 17: The relative out-of-plane displacement of L and Y junctions to slabs

The relative out-of-plane displacements between the top of the L-junction and the top of Y-junction at the ends of the Planar Wall and the top slab are shown in Figure 17a. It can be observed that during initial cycles the deflections of the junctions at the two locations are comparable. However, with larger drift cycles, the Y-junction showed a tendency to deform in the positive direction

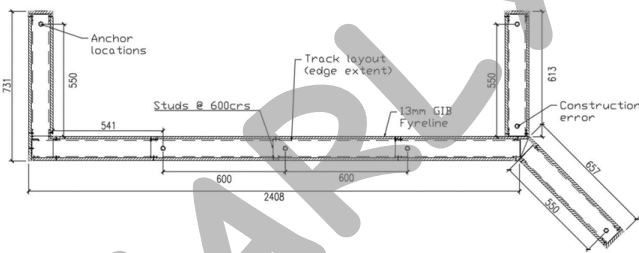
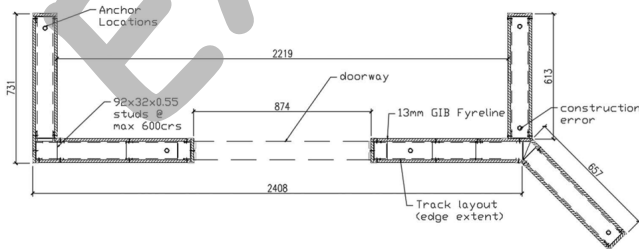
(a) Specimen A1 and A2- Plan

(b) Specimen A3 -Plan

Figure 18: Steel-framed "partly-sliding" internal partition wall specimens tested by [30]

The PSW specimens were comprised of two main modifications to the GIB Fire Rated Systems [26]. The partition walls, with a 60-min fire-resistance rating (GBS60), underwent: 1) removal of the top track anchors within the periphery of wall junctions to allow bowing of the tracks at these intersections under relative displacements, and 2) fixing of the gypsum plasterboards to the bottom tracks between each stud (not to the top tracks) so that the plasterboards remain stationary while the steel-studs slide within the steel-tracks under seismic actions. Further details on the PSW specimens and their seismic performance under bi-directional lateral cyclic drifts can be found in [30].

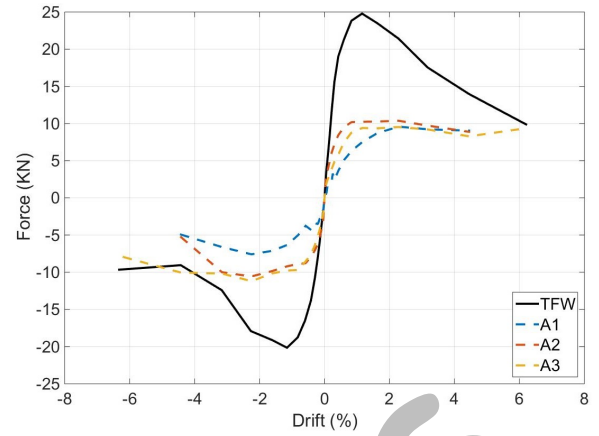
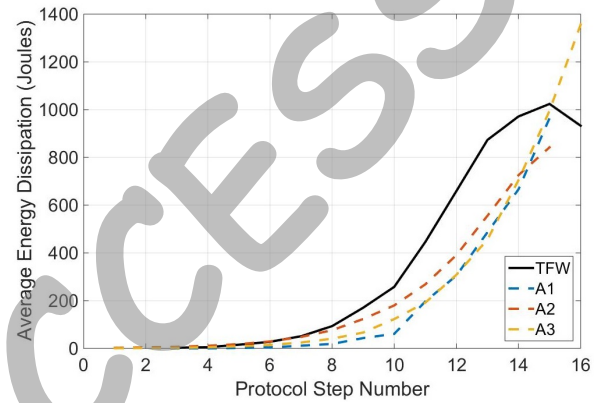
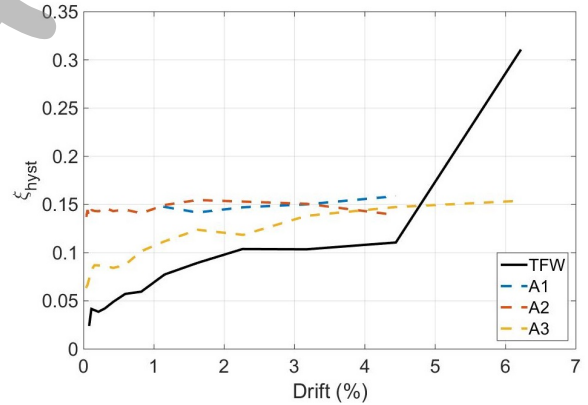
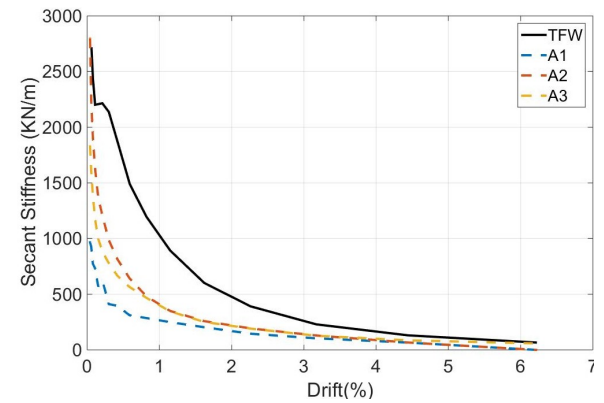
(a) Backbone curves

(b) Average energy dissipation

(c) Equivalent viscous damping coefficient

(d) Secant-stiffness degradation

Figure 19: Comparison between TFW and PSW (A1, A2, and A3) specimens from [30]

energy dissipation, damping coefficient, and secant stiffness degradation between the reported results of PSW specimens and the tested TFW specimen herein are shown in Figure 19.

From Figure 19a, it can be observed that the ultimate strength of the TFW specimen is about twice of that of the PSW specimens. The post-peak downward slope of the load-displacement envelope of TFW indicates a ductile failure mode with signifi-
